## THE LAND TITLE BUILDING Philadelphia, Pennsylvania

# PRESERVATION Tech Notes

NUMBER 2

## Stabilization and Repair of a Historic Terra Cotta Cornice

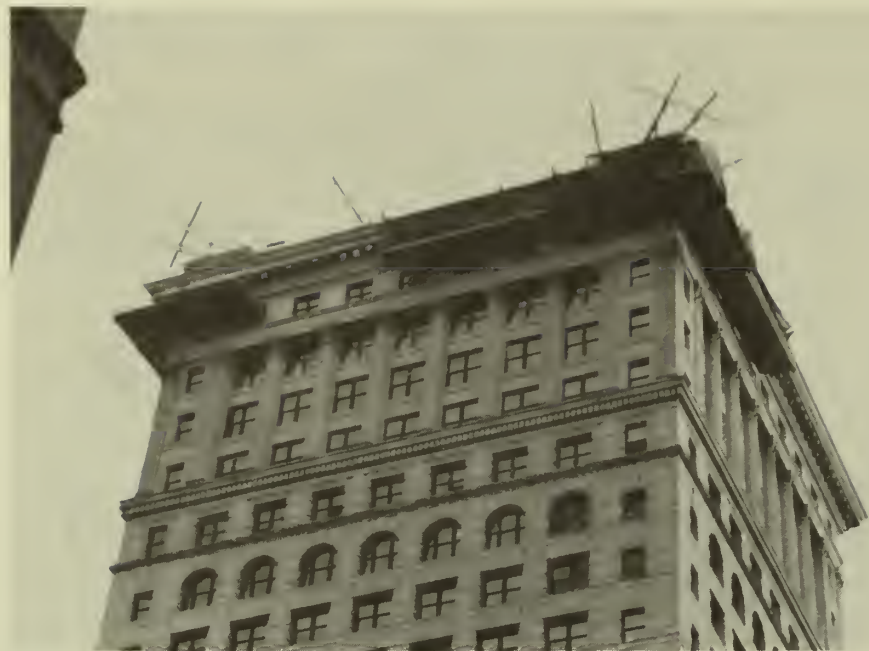
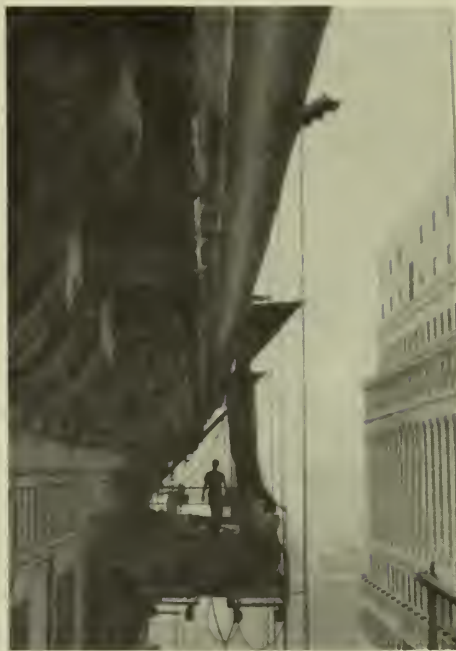
Figure 8. Access to the cornice was provided by cantilevered aerial scaffolds at the southeast and southwest corners of the cornice. All other locations were accessed by hanging two swing stages, side by side. The inner swing was hung off of a V-shaped bracket (shown) while the outer swing was hung from a steel deadman which projected horizontally across the cornice roof. Both the V-shaped bracket and the deadman were designed to transfer the weight of the swings vertically down through the center of the cornice. No load was placed on the outer edge of the cornice. Photos by Jeffrey S. Levine.

The use of swing-stage scaffolds proved to be a practical solution. To accommodate the tall projecting cornice, custom-fabricated brackets were made which permitted two swing-stage scaffolds to be hung side by side, parallel to and at a distance of about 2' out from the exterior wall. By tying the swing stages together and to the building, a stable work platform was provided for both the architect's detailed analysis of the cornice as well as the subsequent repair work (see figure 8). A narrow section of scaffolding placed on the deck of the swings allowed for work on the upper reaches of the cornice. Using 32' long swings, roughly 10 drops were required, with 1½ days of breakdown and setup time between drops. Two sets of double swings were employed for the job.

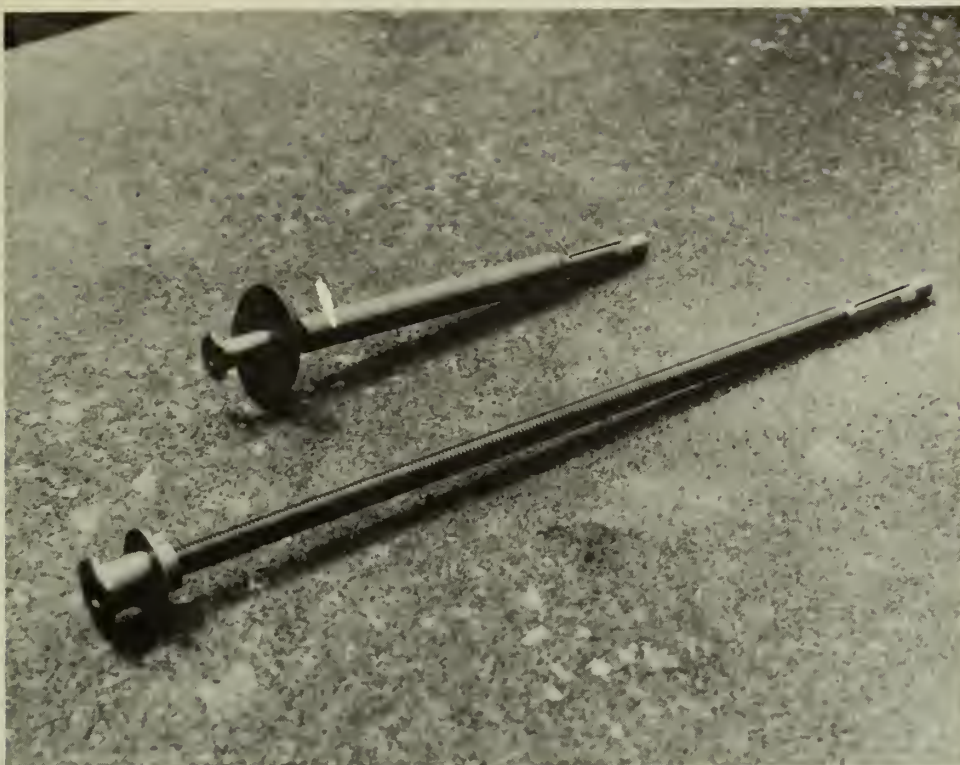
**Figure 10.** A standard mechanical anchor (top) and a variable length mechanical anchor. The variable length anchors were fabricated from 6' long threaded stainless steel rods, which were tapped at both ends to receive expansion assemblies (two anchors could be cut from each rod).

Stainless steel mechanical anchors,  $\frac{7}{16}$ " in diameter and with bronze expansion assemblies, were employed for most other anchoring needs (see figure 10). Anchors of various lengths were special ordered from the manufacturer. The specified lengths were established in the planning phase by drilling test holes in the cornice at what were thought to be typical anchoring locations. A variable length anchor was also developed for use in unanticipated locations and in areas of the cornice where the original construction differed materially from the area in which test borings were conducted (see figure 10).

unknown condition of the masonry backup. Pull-out tests were conducted on a large random sample of installed anchors. Utilizing a safety factor of four, very few anchors failed. Those that did fail had been anchored into masonry backup and were easily replaced after drilling deeper into the backup material.
